NUBANUSIT LAKE DAM

NH 00339

PHASE I INSPECTION REPORT NATIONAL DAM INSPECTION PROGRAM

AUGUST 1978

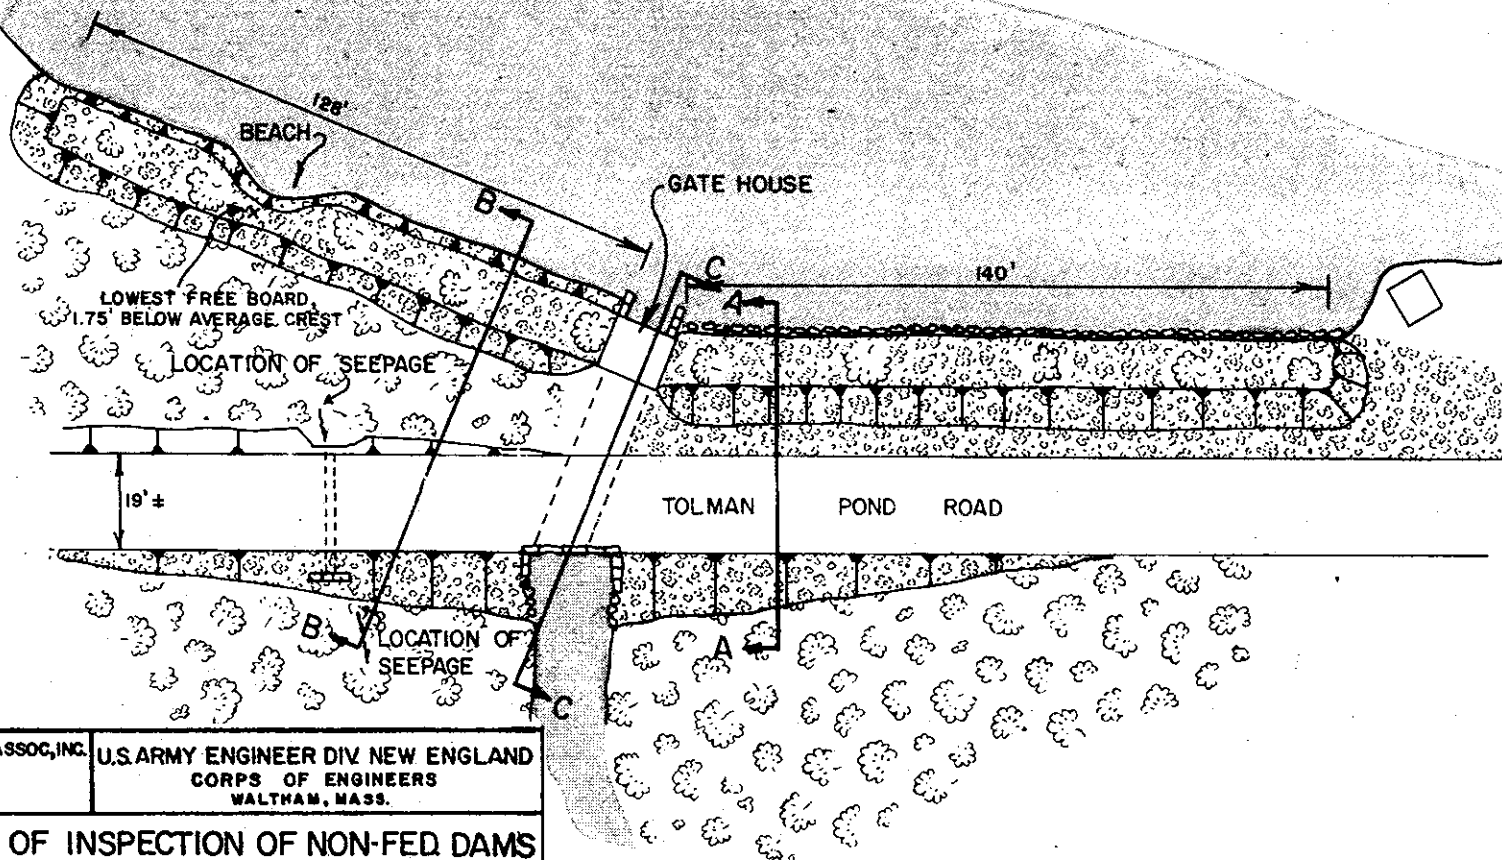
FIGURE 2

Inspection of the embankment revealed two low volume seepage points on the right side of the dam. As indicated in Figure 2 there is a 0.05 gpm flow of slightly discolored seepage at the toe of the right embankment near the inlet to a 16 inch culvert under Tolman Pond Road. The area is in the drainage ditch for the road, but the primary flow issues directly from the embankment. The second flow, of about 0.1 gpm, is across Tolman Pond Road and about 10 feet from the outlet of the culvert mentioned above. Since the general area of this seepage is also in an area through which surface drainage would flow, positive identification of the flow as seepage through the dam is not possible.

Operationally, the dam requires at least monthly monitoring of the two seepage points noted, increased attention to the condition of the embankment in terms of repair of erosion, additional riprap and removal of trees, repair of the upstream wingwalls and clearing of the immediate downstream channel. The installation height of the gage requires verification and some minor changes in the normal operational procedure will improve the owner's ability to handle emergencies.

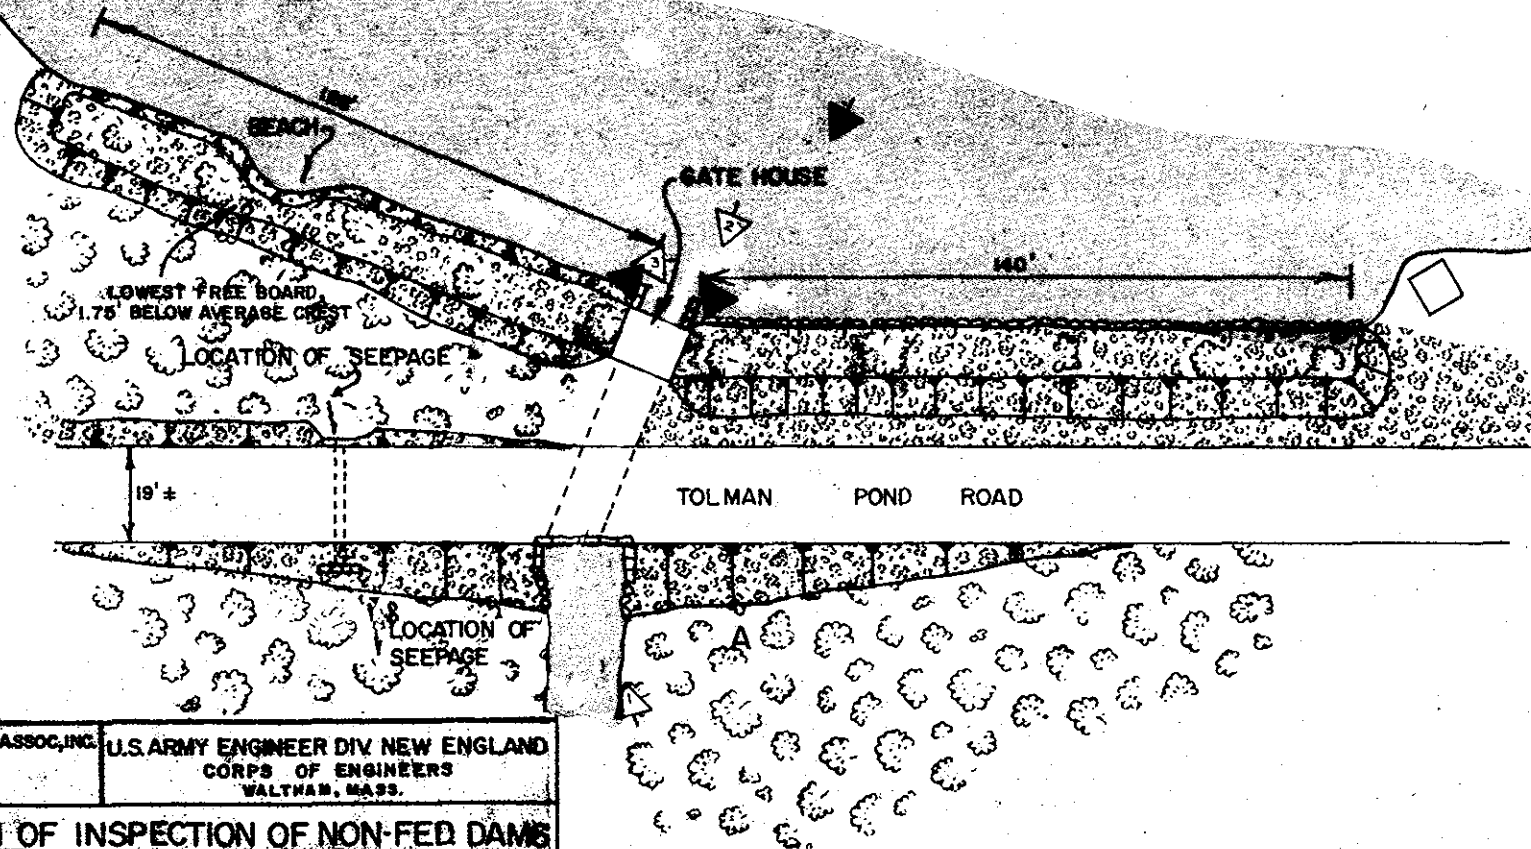
3. Detail of photo 1 from right side of gatehouse
